Inspection Report

Property Address:
1234 Your St.
Bothell WA 98011

Transparent Inspections

Date: 12/2/2013	Time: 10:15 AM	Report ID: AM131
Property: 1234 Your St. Bothell WA 98011	Customer: Joe and Sue Smith	Real Estate Professional:

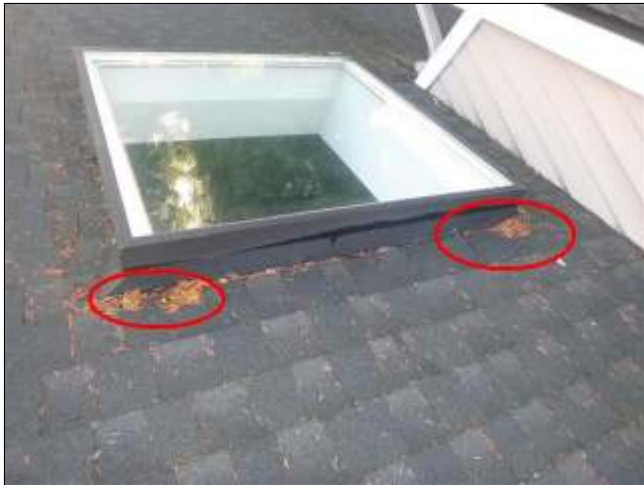
1.2 Item 1(Picture)

1.2 (1) Flashing above skylights has a minimal slope, debris easily builds up. Water can pool and intrude under shingles. recommend cleaning and installing flashing that has a more pronounced slope.

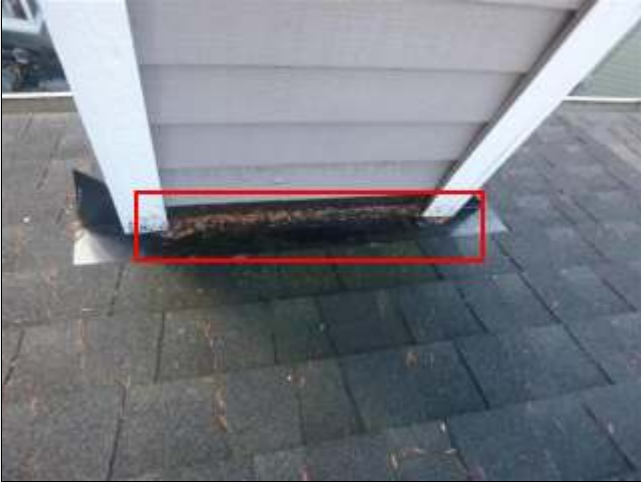
1.2 Item 2(Picture)

1.2 (2) Flashing the chimney has no slope, this can lead to water pooling and moisture intrusion under shingles. Recommend installing flashing with a more pronounced slope.

(2) Flashing the chimney has no slope, this can lead to water pooling and moisture intrusion under shingles. Recommend installing flashing with a more pronounced slope.

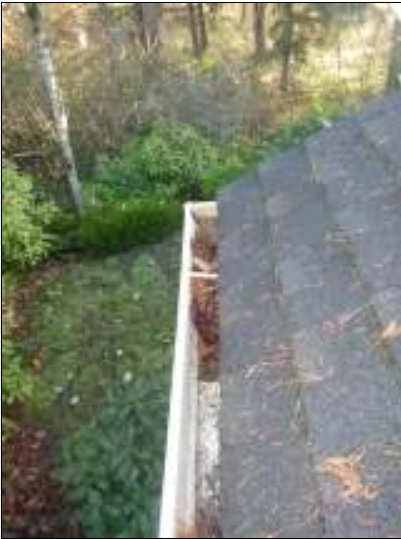
1.3 Item 1(Picture)

1.3 Gutters have excessive debris buildup. Can cause clogging and water pooling. Recommend cleaning.

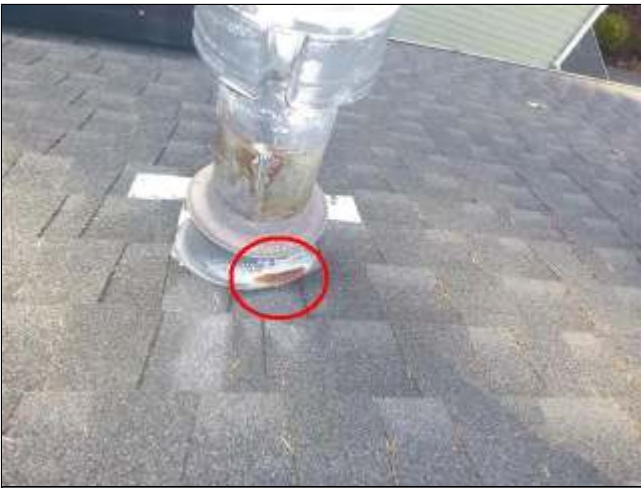
1.5 Item 1(Picture)

1.5 Furnace vent is showing signs of corrosion. Recommend monitoring and replacing before holes form.

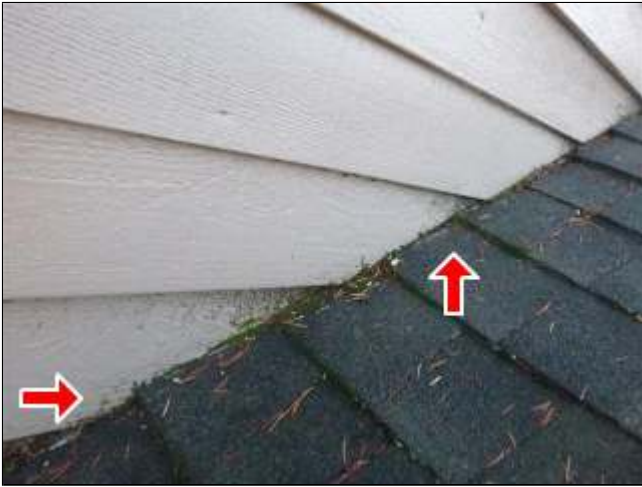
2.0 Item 1(Picture)

2.0 (1) Siding is touching roofing material and is starting to show signs of wood rot. Recommend cutting siding back two inches and installing proper flashing.

(1) Siding is touching roofing material and is starting to show signs of wood rot. Recommend cutting siding back two inches and installing proper flashing.

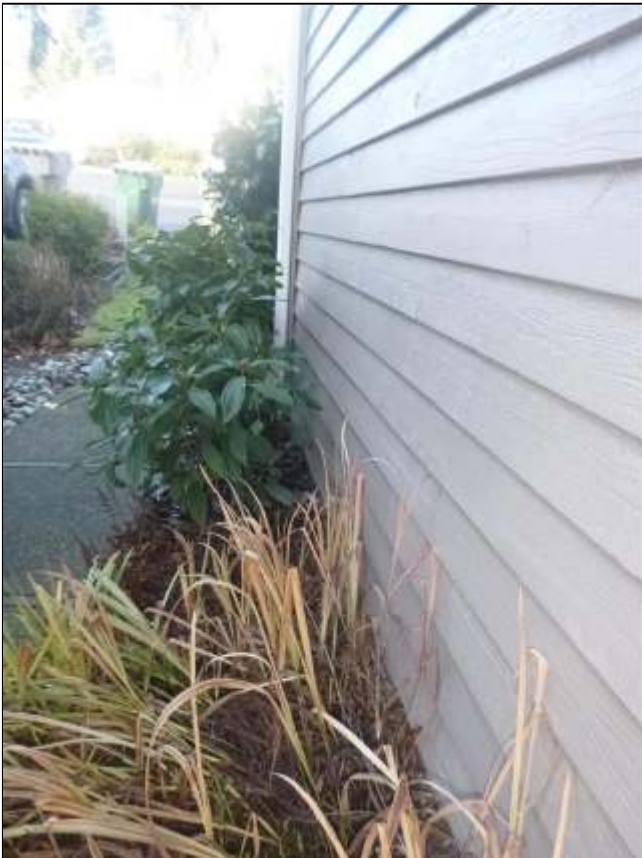
2.0 Item 2(Picture)

2.0 (2) There is vegetation in contact with the siding of the home. This is a conducive condition for wood destroying organisms. Recommend vegetation to be removed/cut back from siding by 6-8 inches.

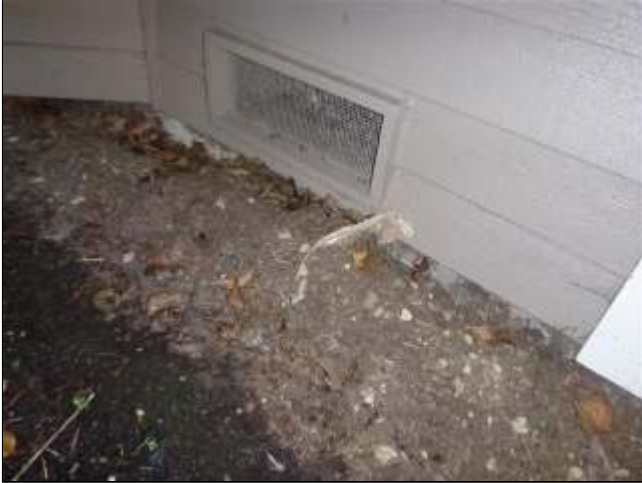
2.0 Item 3(Picture)

2.0 (3) Siding in contact with ground at North side of home. Because the siding is in contact with ground it is possible for framing to be deteriorated. We did not inspect behind this siding. Recommend a ground clearance of six to eight inches where possible.

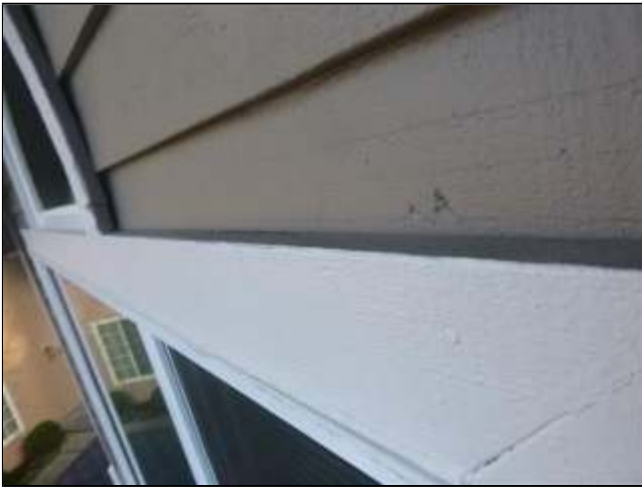
2.2 Item 1(Picture)

2.2 Windows on front and sides of home do not have flashing above trim. This can allow water to penetrate inside the walls of the home. Recommend installing flashing above all windows by licensed contractor.

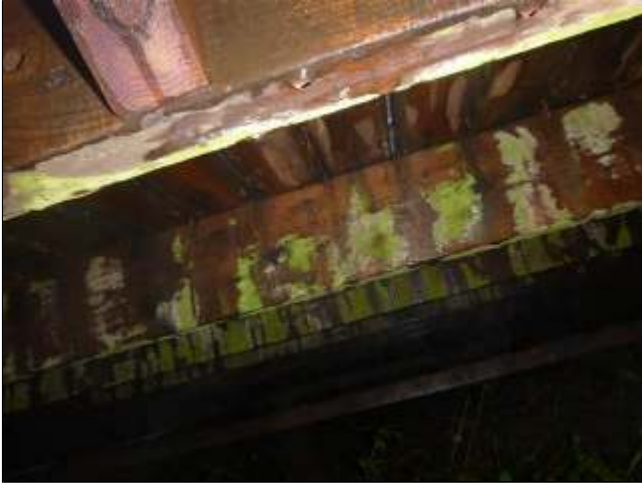
2.3 Item 1(Picture)

2.3 Underside of deck has excessive build up of mildew. This can lead to wood rot over time. Recommend cleaning and sealing as needed.

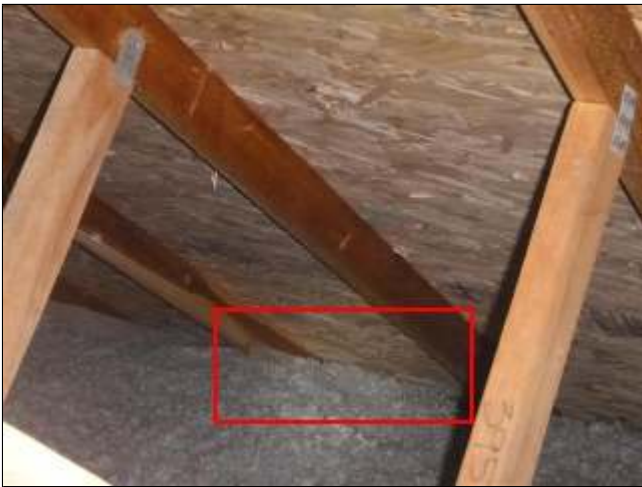
3.2 Item 1(Picture)

3.2 Some of the soffit vents have insulation blown into the baffles which obstructs ventilation. Recommend cleaning baffles.

Some of the soffit vents have insulation blown into the baffles which obstructs ventilation. Recommend cleaning baffles.

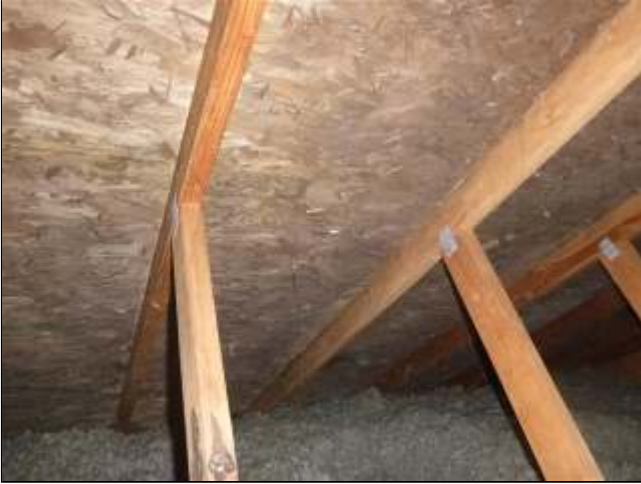
3.3 Item 1(Picture)

3.3 Underside of sheathing on north side is discolored. This is indicative of microbial growth due to high moisture content of the air. Recommend increasing ventilation, and repairing ducting to prevent excess moisture buildup.

Underside of sheathing on north side is discolored. This is indicative of microbial growth due to high moisture content of the air. Recommend increasing ventilation, and repairing ducting to prevent excess moisture buildup.

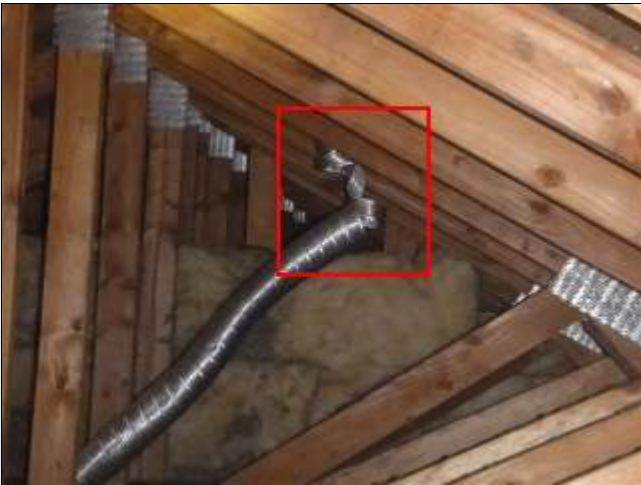
3.4 Item 1(Picture)

3.4 Air vent duct from master bath is damaged and is leaking damp air into attic. Recommend having licensed contractor replace duct.

Air vent duct from master bath is damaged and is leaking damp air into attic. Recommend having licensed contractor replace duct.

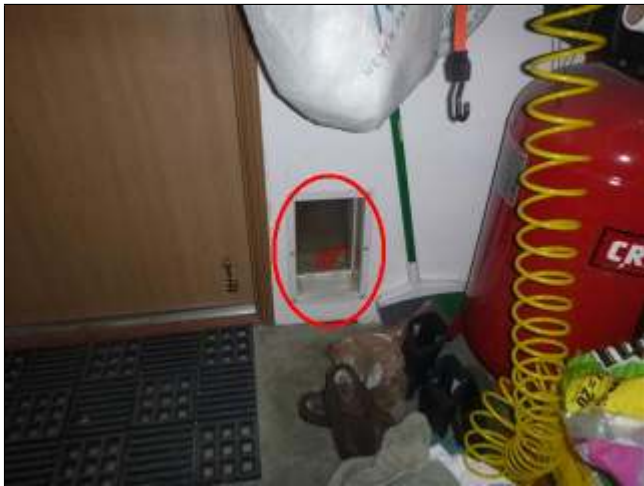
4.1 Item 1(Picture)

4.1 Garage has a pet door installed next to interior door. This compromises the fire wall and is against code. Recommend having licensed contractor patch and repair.

Garage has a pet door installed next to interior door. This compromises the fire wall and is against code. Recommend having licensed contractor patch and repair.

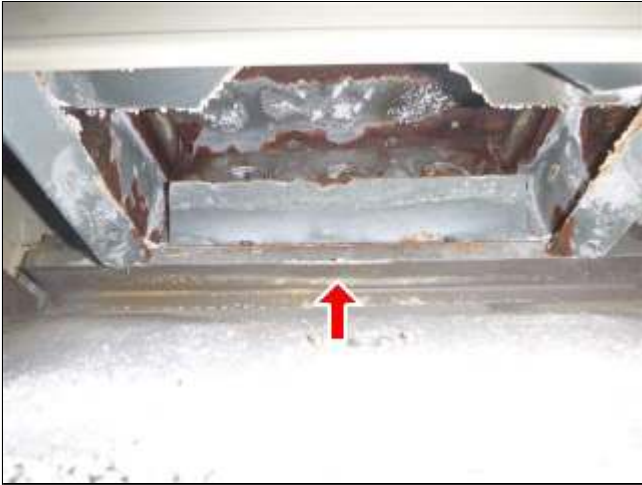
5.0 Item 1(Picture)

5.0 (1) Vent stack of furnace is heavily corroded, and there was debris sitting in and around furnace. This indicates incomplete burning of fuel, and/or a crack/leak in the heat exchanger. Recommend licensed HVAC contractor to assess and repair/replace as needed.

(1) Vent stack of furnace is heavily corroded, and there was debris sitting in and around furnace. This indicates incomplete burning of fuel, and/or a crack/leak in the heat exchanger. Recommend licensed HVAC contractor to assess and repair/replace as needed.

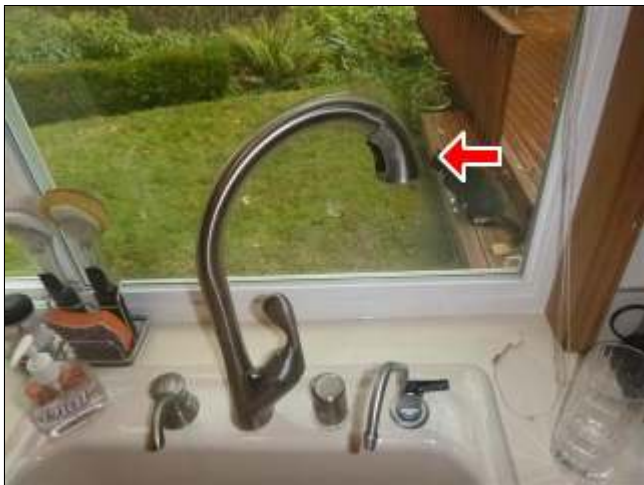
7.0 Item 1(Picture)

7.0 Faucet swivels past sink and can spill water onto counter. This is a hazard and recommend installing a stop to prevent this.

Faucet swivels past sink and can spill water onto counter. This is a hazard and recommend installing a stop to prevent this.

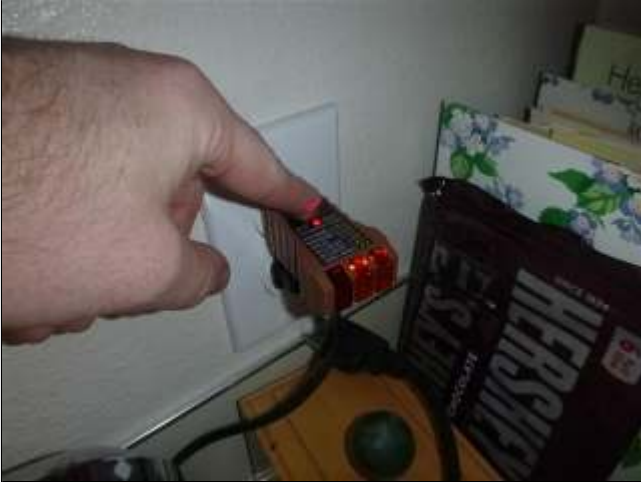
7.5 Item 1(Picture)

7.5 Kitchen outlets are not GFCI protected and are required to be by code. Recommend having licensed electrician install GFCI for all outlets in kitchen.

10.3 See kitchen 7.5

Kitchen outlets are not GFCI protected and are required to be by code. Recommend having licensed electrician install GFCI for all outlets in kitchen.

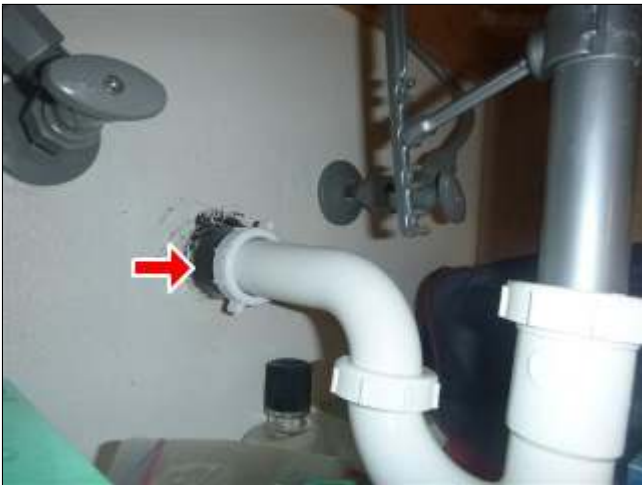
8.0 Item 1(Picture)

8.0 (1) Drain pipe in master bath sink on right side has a negative slope. This allows pooling and does not drain properly. Recommend licensed plumber to repair.

(1) Drain pipe in master bath sink on right side has a negative slope. This allows pooling and does not drain properly. Recommend licensed plumber to repair.

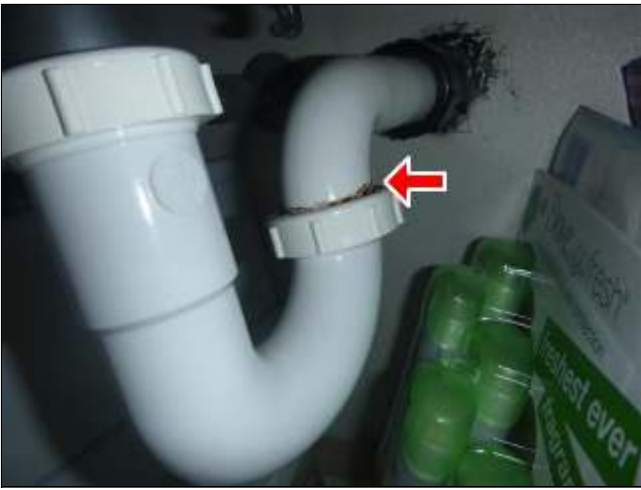
8.0 Item 2(Picture)

8.0 (2) Master bath sink on left side has a minor leak in the drain pipe. Recommend repair by licensed plumber.

(2) Master bath sink on left side has a minor leak in the drain pipe. Recommend repair by licensed plumber.

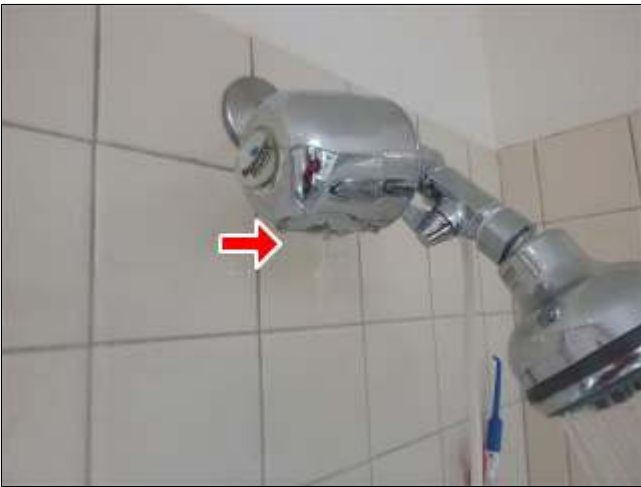
8.1 Item 1(Picture)

8.1 Master bath shower head has a leak. Recommend repairing to prevent water damage.

Master bath shower head has a leak. Recommend repairing to prevent water damage.

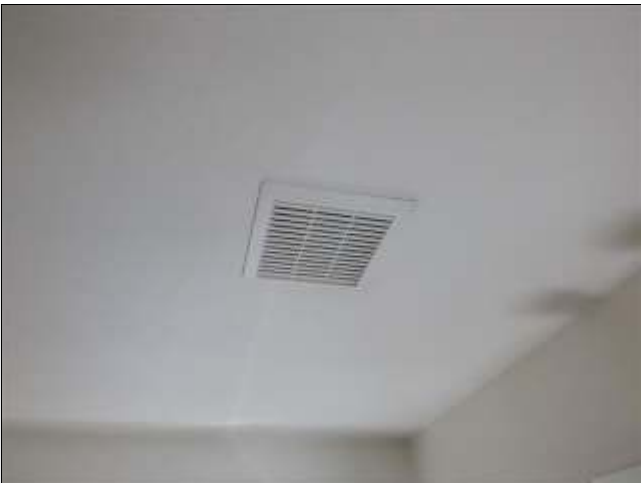
8.5 Item 1(Picture)

8.5 Upstairs bath fan does not appear to be venting. No ducting was found in attic, and there is no suction. Recommend licensed contractor to install proper ducting for ventilation.

Upstairs bath fan does not appear to be venting. No ducting was found in attic, and there is no suction. Recommend licensed contractor to install proper ducting for ventilation.

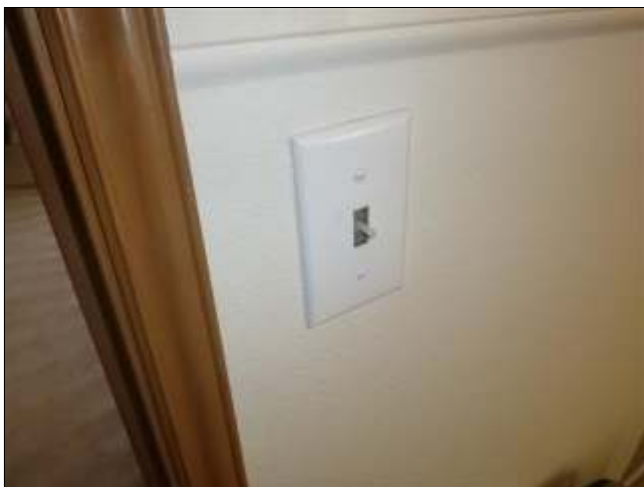
10.2 Item 1(Picture)

10.2 Dimmer light switch is missing knob. Due to difficulty of use, can be a hazard. Recommend replacing with functioning switch.

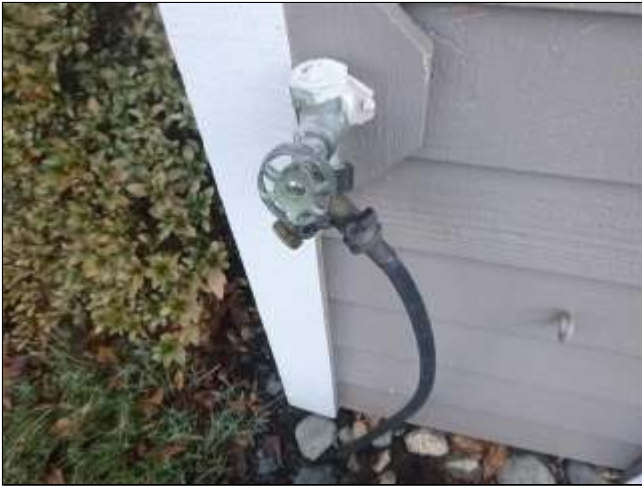
11.6 Item 1(Picture)

11.6 Could not get front hose bib to work. Possibly shut off at different location. If not, recommend licensed plumber to repair.

Could not get front hose bib to work. Possibly shut off at different location. If not, recommend licensed plumber to repair.

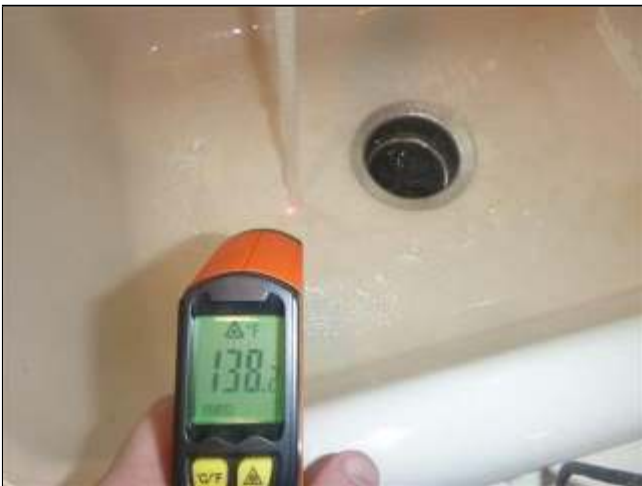
11.8 Item 1(Picture)

11.8 Water temperature is 138 F. This is too hot and can cause burns. Recommend setting water heater to a lower setting, for a temp. of 120-125.

Water temperature is 138 F. This is too hot and can cause burns. Recommend setting water heater to a lower setting, for a temp. of 120-125.

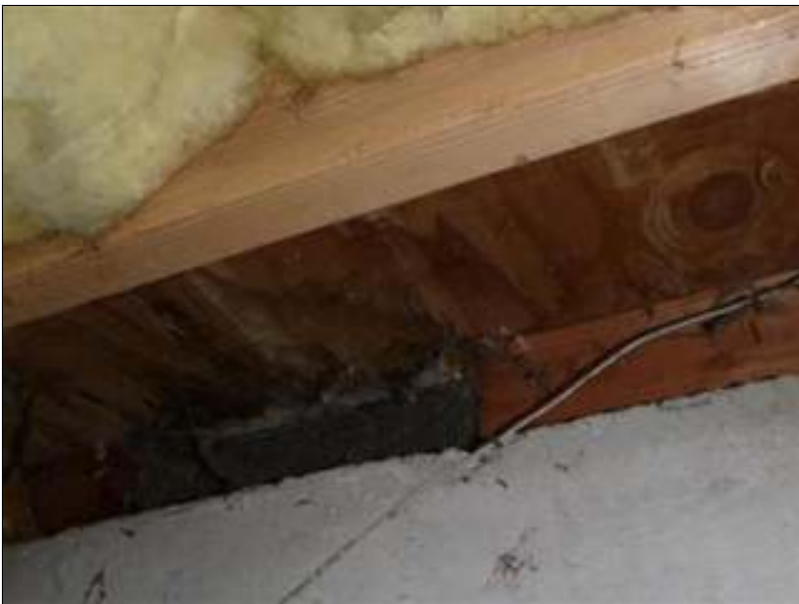
12.2 Item 1(Picture)

12.2 Flooring in rear of home by back deck has water staining. It appears that this is due to the incorrect flashing around a vent under the deck. Recommend having contractor install flashing to divert water away and replace damaged material.

Flooring in rear of home by back deck has water staining. It appears that this is due to the incorrect flashing around a vent under the deck. Recommend having contractor install flashing to divert water away and replace damaged material.

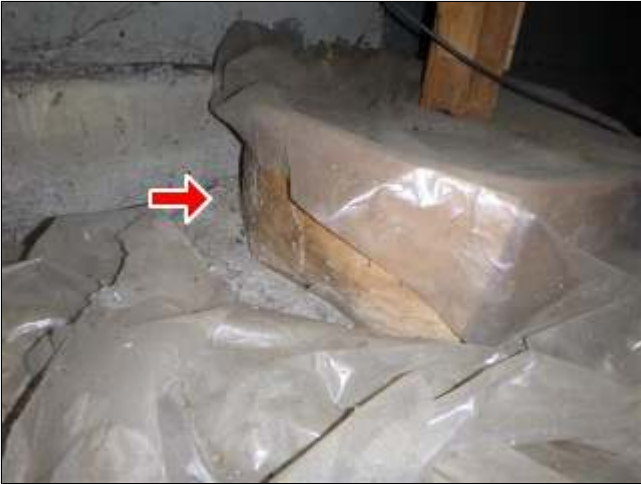
12.3 Item 1(Picture)

12.3 Columns still have cardboard forms in place around piers. This is a conducive condition for wood destroying organisms. Recommend removing cardboard forms.

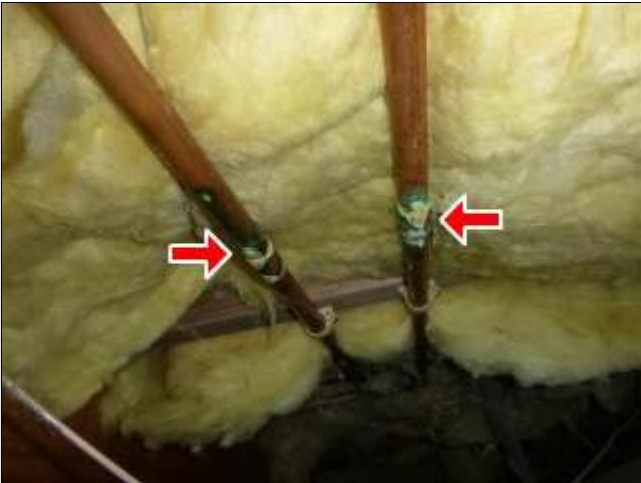
12.5 Item 1(Picture)

12.5 Several copper pipes are corroding and could leak. Recommend having licensed plumber repair.
