Prepared by:
Austin McFeeley

Table of contents

Property & Inspection Details

Single Family

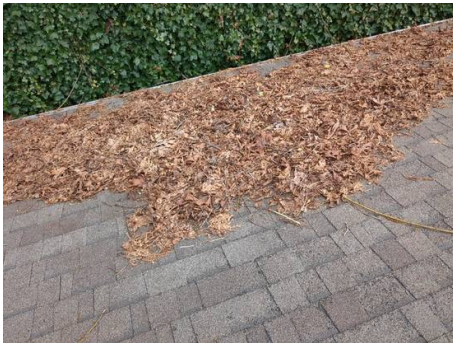
There is excessive debris and/or vegetation on the roof. This can allow water to sit on the roof and/or can block drainage. Recommend that the roof be cleaned, not by power washing.

There is excessive debris and/or vegetation on the roof. This can allow water to sit on the roof and/or can block drainage. Recommend that the roof be cleaned, not by power washing.

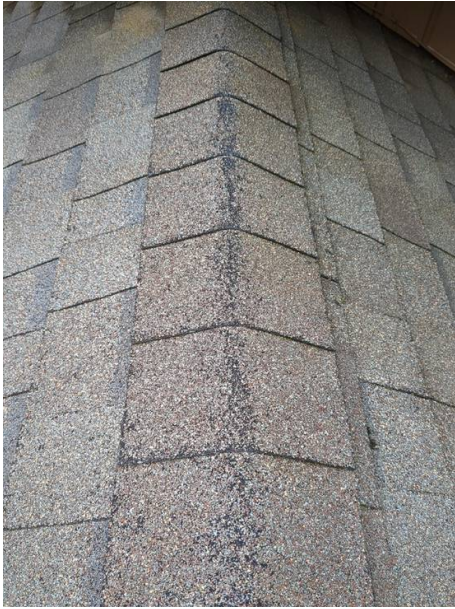
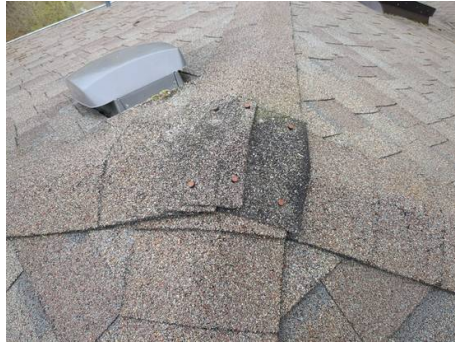
Roof Coverings

There are a number of shingles, most on the ridge, that have extra wear on them, almost certainly due to birds and/or squirrels. These shingles will need attention before the remainder of the roof does. Monitor and repair/replace as needed.

There are a number of shingles, most on the ridge, that have extra wear on them, almost certainly due to birds and/or squirrels. These shingles will need attention before the remainder of the roof does. Monitor and repair/replace as needed.

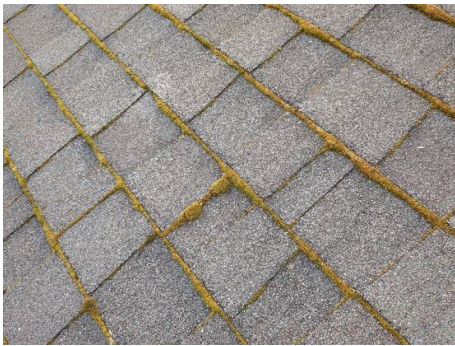
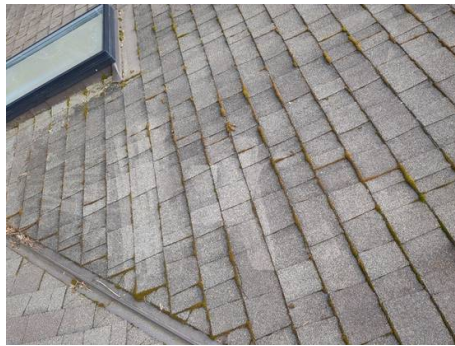
Roof Coverings

There is moss beginning to growing on the roof. Moss can also shorten the life of the roof by growing into the roofing material, both providing access for moisture and removing the covering. Recommend that the roof be treated, and if desired, cleaned but not by pressure washing.

There is moss beginning to growing on the roof. Moss can also shorten the life of the roof by growing into the roofing material, both providing access for moisture and removing the covering. Recommend that the roof be treated, and if desired, cleaned but not by pressure washing.

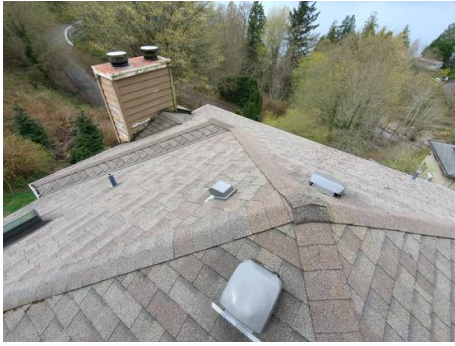
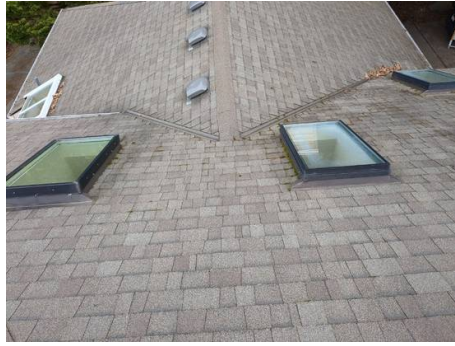
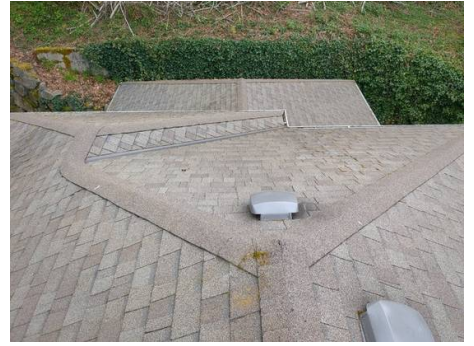
Roof Coverings

The roof is in overall acceptable condition. with proper maintenance and cleaning this should last for approximately 10 more years. This is for your information.

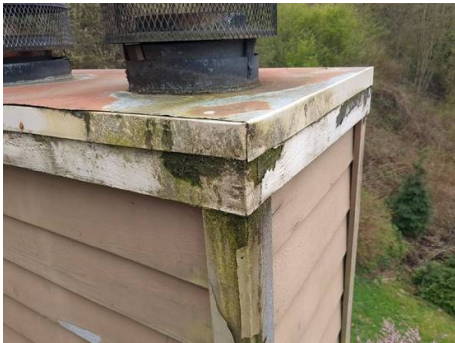
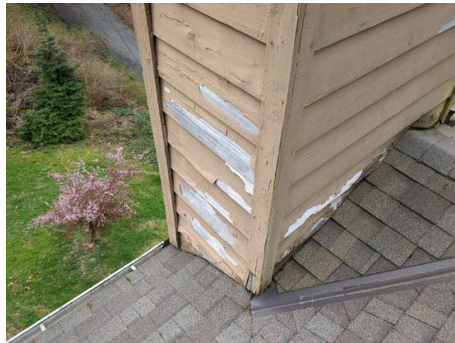
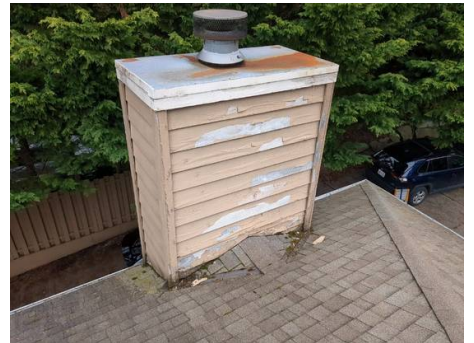
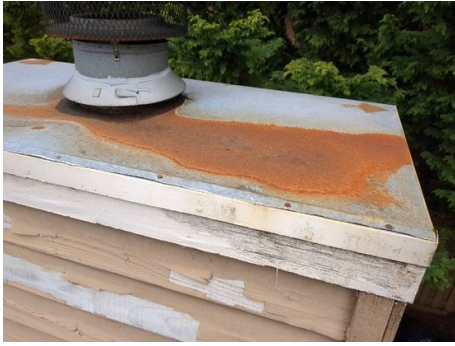
Metal cap of chimney is inverted and is holding water and edge does not appear well sealed. This could potentially lead to water infiltration and damage. Recommend repair as needed.

The siding is deteriorated on bottom edge where the roof meets the siding of the chimney. Because the siding is in contact with the roof it is possible for framing to be deteriorated. We did not inspect behind this siding. A qualified contractor should inspect and repair as needed, most likely by cutting back the siding 1-2 inches.

Metal cap of chimney is inverted and is holding water and edge does not appear well sealed. This could potentially lead to water infiltration and damage. Recommend repair as needed.

The siding is deteriorated on bottom edge where the roof meets the siding of the chimney. Because the siding is in contact with the roof it is possible for framing to be deteriorated. We did not inspect behind this siding. A qualified contractor should inspect and repair as needed, most likely by cutting back the siding 1-2 inches.

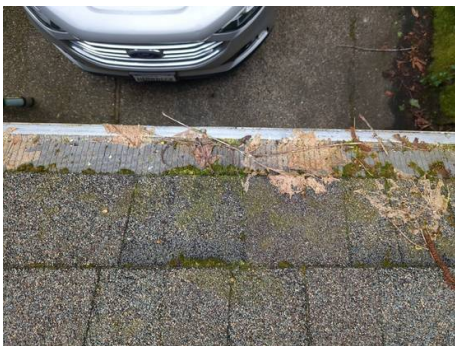
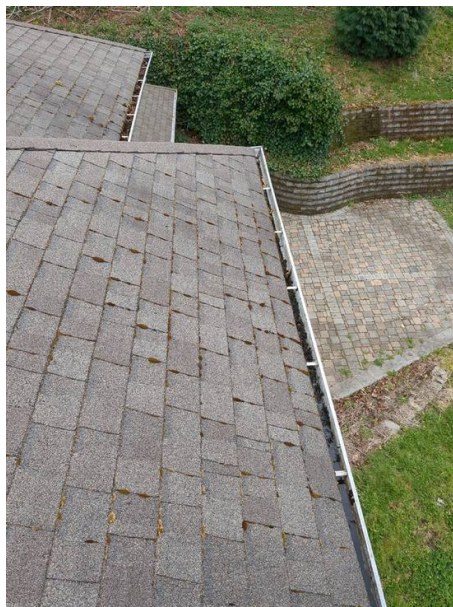
Gutters have vegetation clogging them and some water due to the blockage. Recommend gutters to be cleaned immediately and monitored in the future as this will be a reoccurring issue.

The gutters have a guard. This is a preventive measure to help keep debris out of the gutters. These have varying measures of success. It is still recommended to monitor gutters for clogging. For your information.

Gutters have vegetation clogging them and some water due to the blockage. Recommend gutters to be cleaned immediately and monitored in the future as this will be a reoccurring issue.

The gutters have a guard. This is a preventive measure to help keep debris out of the gutters. These have varying measures of success. It is still recommended to monitor gutters for clogging. For your information.

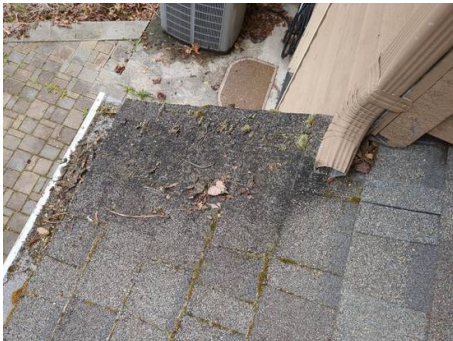
Gutter from upper level discharges its water onto the roof of the lower level. This puts the water at an angle that could possibly go under shingles. This also causes extra wear at this location. Recommend corrective action be taken, either metal flashing, adding a 90 degree angle to the downspout, or ideally extending the downspout into the lower gutter.

Gutter from upper level discharges its water onto the roof of the lower level. This puts the water at an angle that could possibly go under shingles. This also causes extra wear at this location. Recommend corrective action be taken, either metal flashing, adding a 90 degree angle to the downspout, or ideally extending the downspout into the lower gutter.

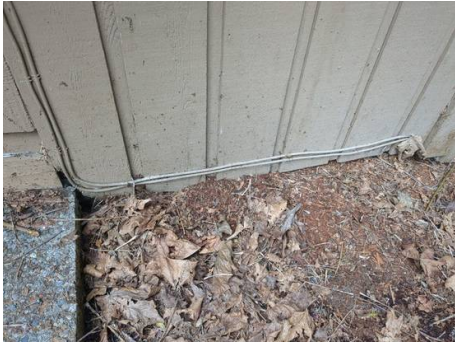
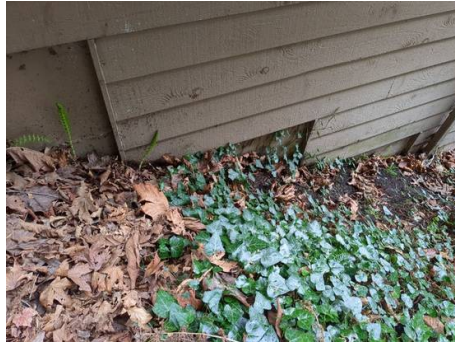
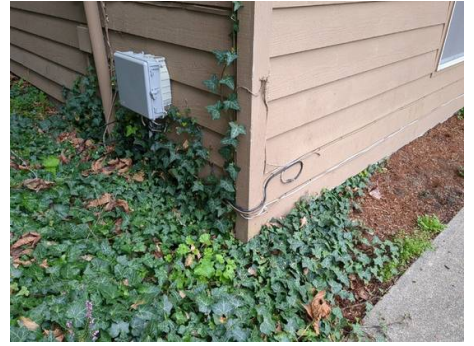
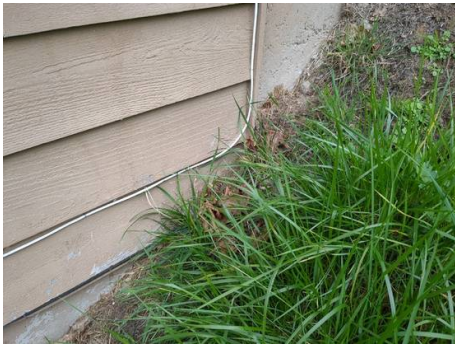
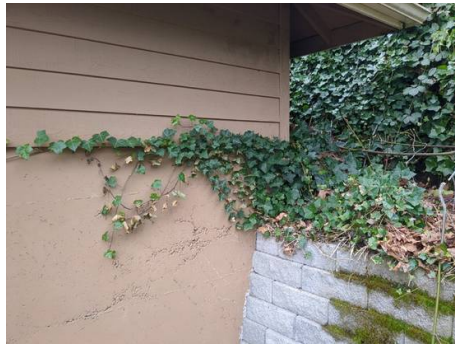
Siding in contact with ground in areas. Because the siding is in contact with ground it is possible for water to penetrate and damage the framing. We did not inspect behind this siding. Recommend a ground clearance of six to eight inches where possible and further exploration.

There is vegetation in contact with the siding of the home. This is a conducive condition for wood destroying organisms. Recommend vegetation to be removed/cut back from siding by 6-8 inches.

Siding in contact with ground in areas. Because the siding is in contact with ground it is possible for water to penetrate and damage the framing. We did not inspect behind this siding. Recommend a ground clearance of six to eight inches where possible and further exploration.

There is vegetation in contact with the siding of the home. This is a conducive condition for wood destroying organisms. Recommend vegetation to be removed/cut back from siding by 6-8 inches.

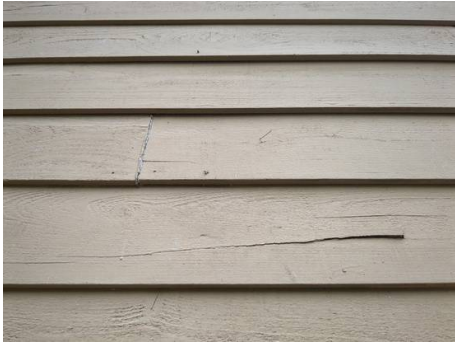
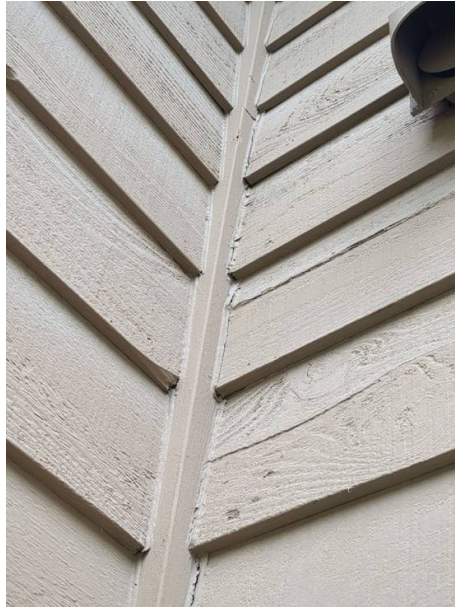
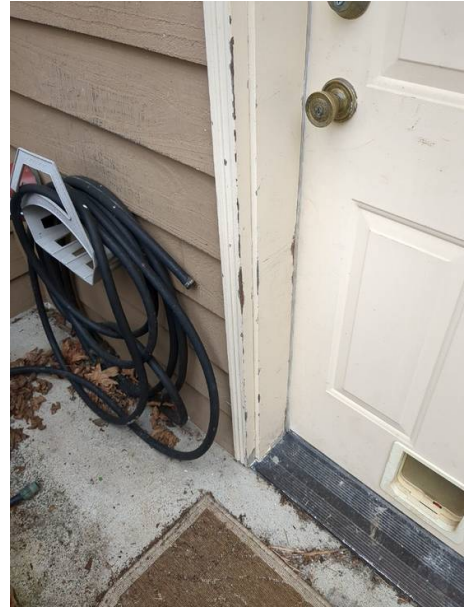
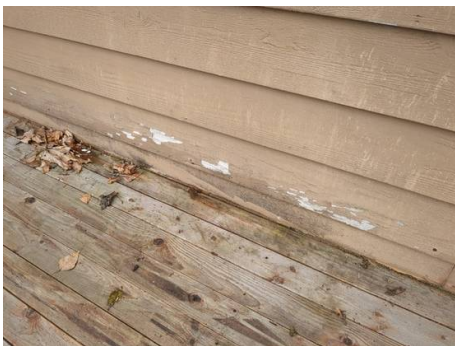
Siding/Flashing/Trim

At the trim, the caulking is failing in several spots. This can potentially allow water intrusion and damage. Typically when some caulking fails, the remainder is nearing that same point. Recommend replacing failed caulking and monitoring the rest for future failure.

Paint failing or peeling on siding and trim in areas. This leaves the siding exposed and can lead to damage. Recommend prep and paint where needed.

At the trim, the caulking is failing in several spots. This can potentially allow water intrusion and damage. Typically when some caulking fails, the remainder is nearing that same point. Recommend replacing failed caulking and monitoring the rest for future failure.

Paint failing or peeling on siding and trim in areas. This leaves the siding exposed and can lead to damage. Recommend prep and paint where needed.

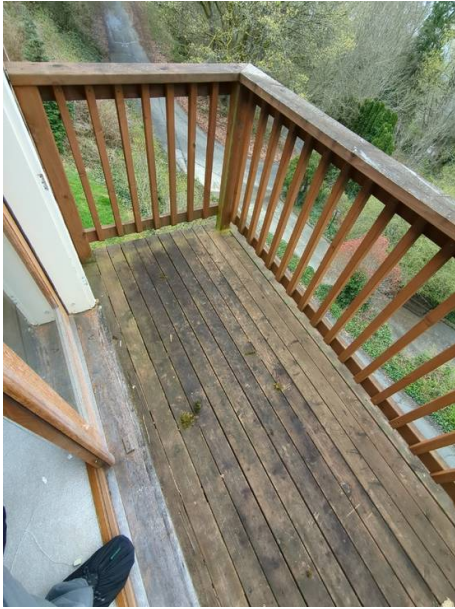
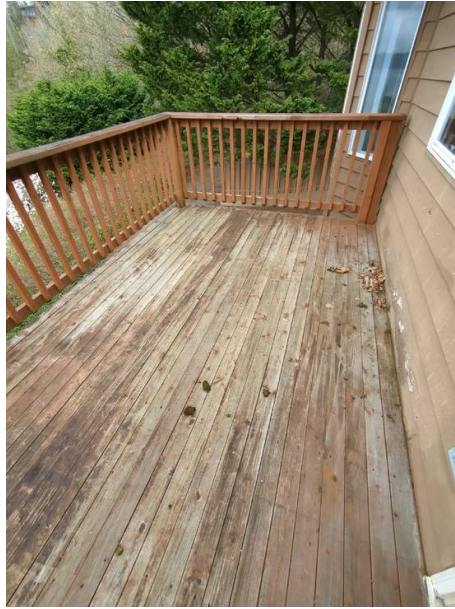
Deck boards are not sealed. This leaves wood exposed and can lead to water damage and deterioration. Recommend that deck be sanded, prepped and sealed.

Deck boards are not sealed. This leaves wood exposed and can lead to water damage and deterioration. Recommend that deck be sanded, prepped and sealed.

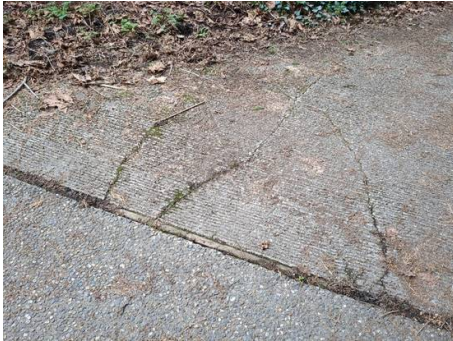
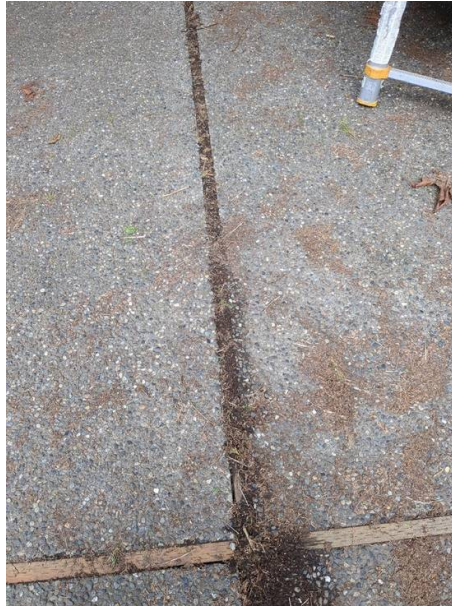
The concrete drive at the front of home has hairline cracks. Water can cause further deterioration if not repaired and sealed properly. Recommend that a patch or seal be installed to prevent water infiltration.

The wood spacers in the driveway are deteriorating. These are to prevent the slabs from moving. Recommend removing and replacing to prolong the life of the driveway.

The concrete drive at the front of home has hairline cracks. Water can cause further deterioration if not repaired and sealed properly. Recommend that a patch or seal be installed to prevent water infiltration.

The wood spacers in the driveway are deteriorating. These are to prevent the slabs from moving. Recommend removing and replacing to prolong the life of the driveway.

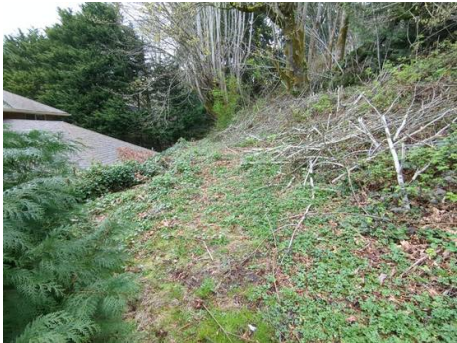
Home sits on Hill, and rear of home has ground sloping towards it. It. This appears to be in good condition at this

time. Recommend monitoring above retaining wall.

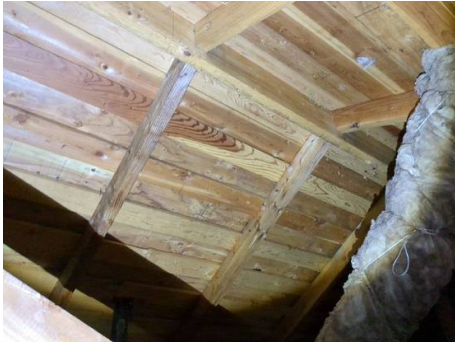
The sheathing is indicative that the original or past roof was a wood shake roof. This is not an issue, but is for your information.

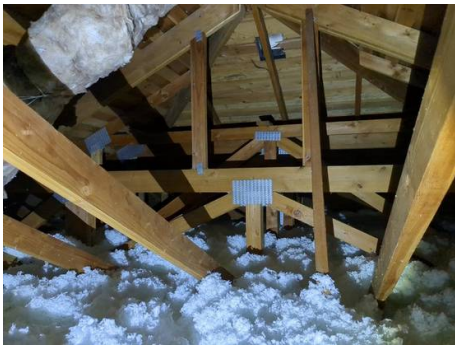
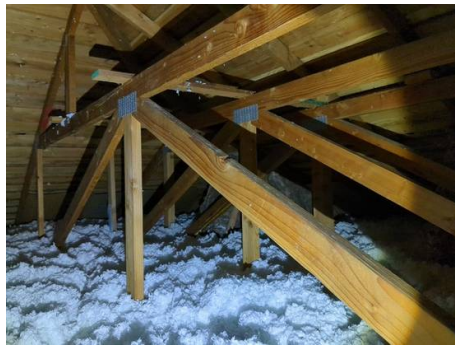
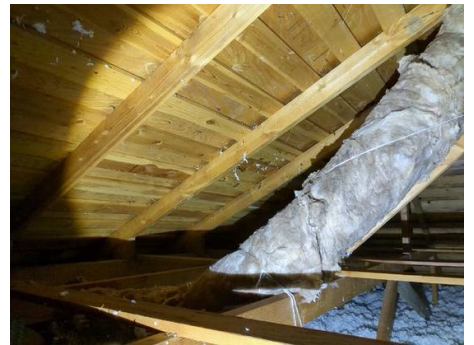
This picture is to show the condition of the attic. No issues were noted. For informational purposes.

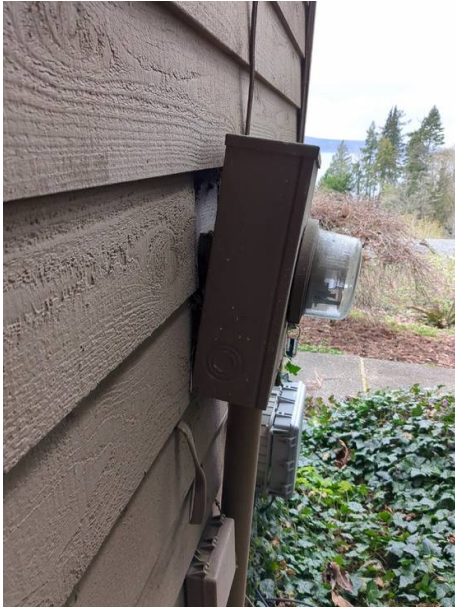
Meter box is pulling away from the wall. This can be a potential hazard and may allow water to penetrate. Recommend properly securing meter box and flashing if needed.

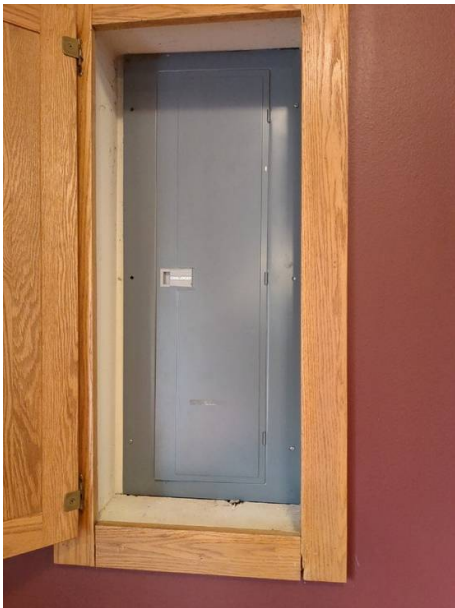
Electric Panel

The main panel is installed in the wall of the basement. Trim has been installed that prevents removal of the dead front. This limits inspection of the main panel. Some of the wiring was visible through knockouts and appears in the order .Recommend that this be further assessed when able.

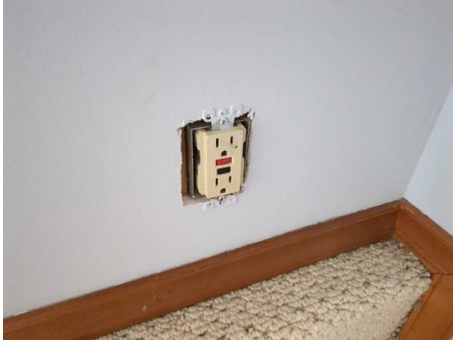
There is an outlet missing a cover. This leaves wires exposed. Recommend installing proper cover for safety.

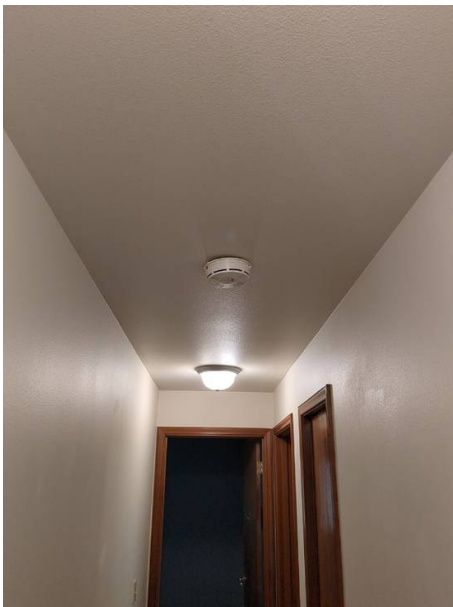
Smoke and Carbon Monoxide Detectors

There is no carbon monoxide detector found in home. It is recommended that at least one per floor be installed according to the manufacturer's instructions per Washington code.

There is no carbon monoxide detector found in home. It is recommended that at least one per floor be installed according to the manufacturer's instructions per Washington code.

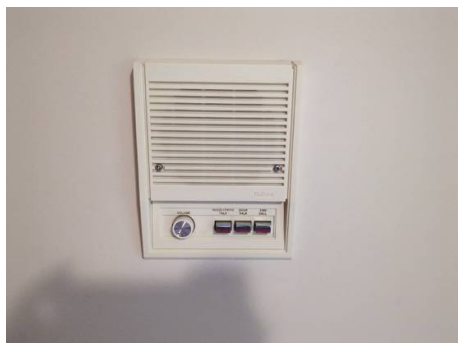
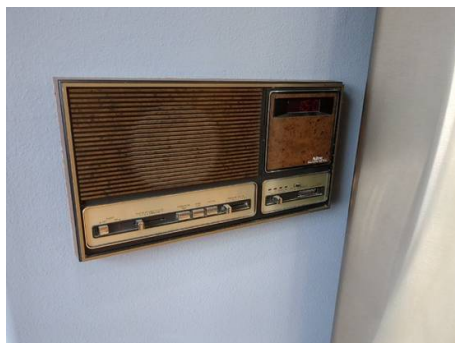
Intercom is present in the home. Appears to be in working order. This is not fully tested. For your information

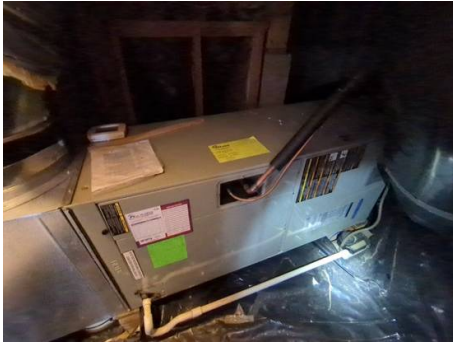
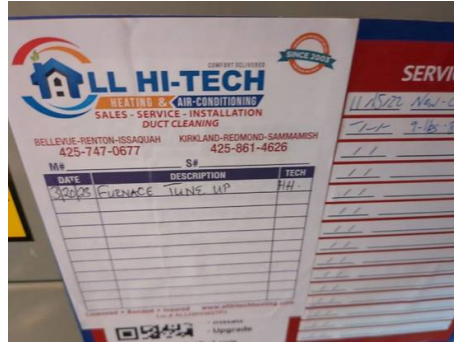
Furnace appears in good working order and has been serviced in the past year. Recommend monitoring and servicing regularly.

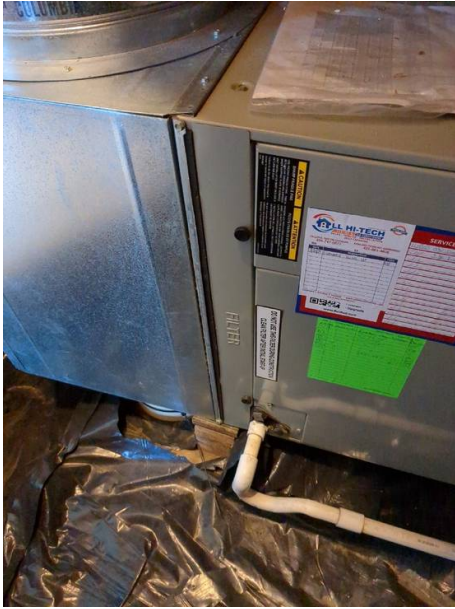
The filter is located next to the interior furnace unit . For your information. Recommend changing paper filter every three months as needed for full use.

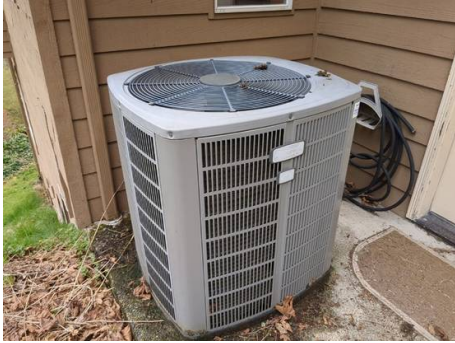
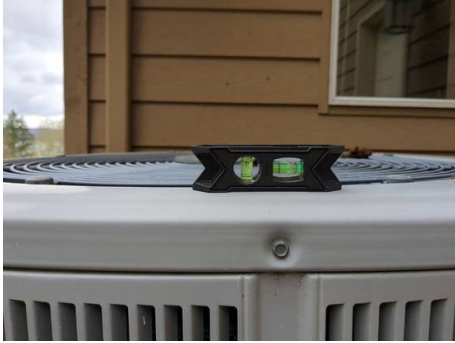
Cooling

The cooling was not tested for proper operation due to the outside air temperature is 65 degrees or less. We did not inspect this unit(s). Recommend servicing annually.

Heat pump is present for heating and cooling. Exterior unit is present and functional at this time. Service regularly. The extra unit is slightly out of level. This can add extra wear to the unit. Recommend the leveling as able.

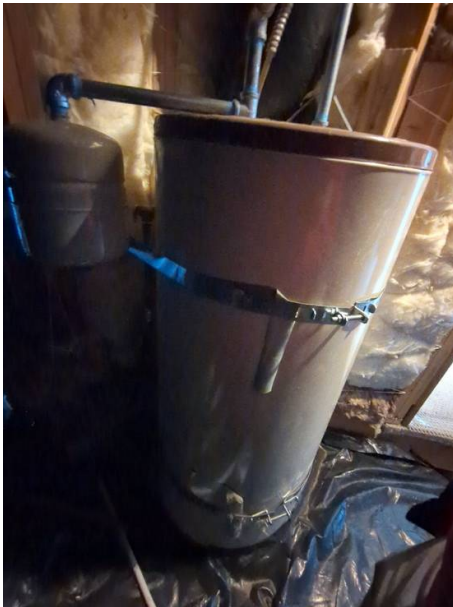
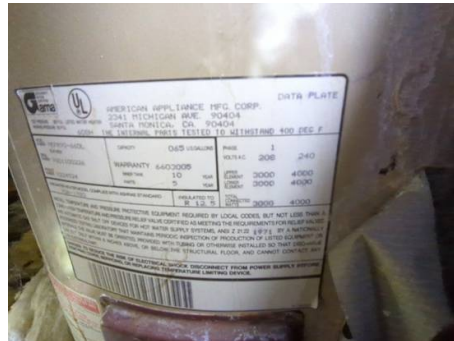
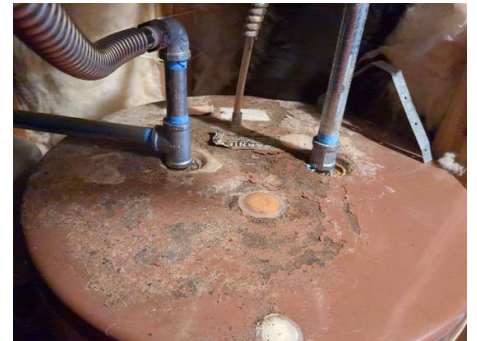
Water heater is 34 years old. Typical water heater design life is between 8-12 years. Due to the age, it could fail at any time. There are signs of corrosion and damage as well. Recommend licensed plumber to replace water heater and install with all safety measures.

Water heater is 34 years old. Typical water heater design life is between 8-12 years. Due to the age, it could fail at any time. There are signs of corrosion and damage as well. Recommend licensed plumber to replace water heater and install with all safety measures.

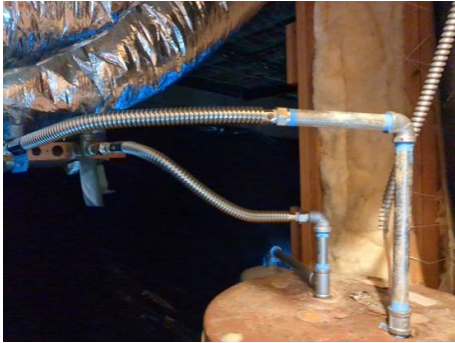
Plumbing

Your water heater does not have a "Thermal Expansion tank" installed to prevent a possible leak at the T&P or "pop-off" valve. These are recommended but not required on electric water heaters. There were no leaks or drips at the T&P valve during inspection. If your water heater does begin to drip or leak, then a thermal expansion tank may be needed.

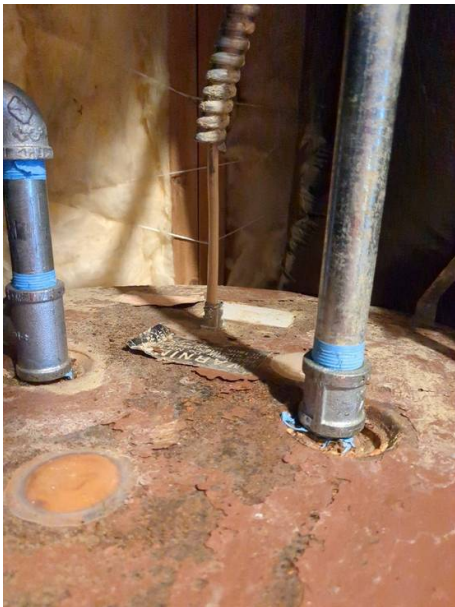
The wiring for the water heater is exposed. Electrical issues are considered a hazard until repaired. I recommend a licensed electrical contractor correct as necessary.

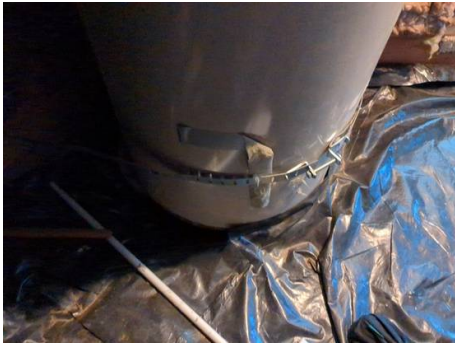
There is no drain pan in place in the event of a leak or overflow. Recommend installing pan when practical and/or a water alarm to alert in the event of leaking.

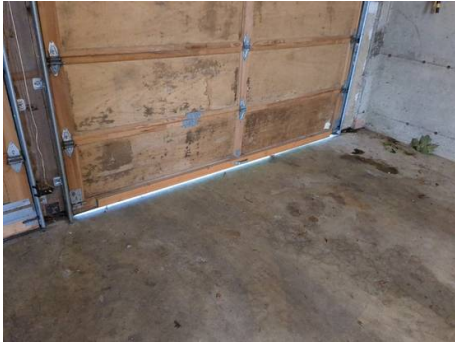
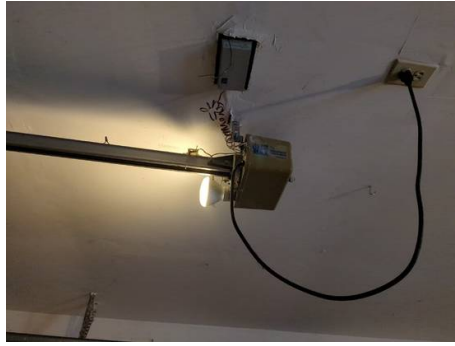
There are no sensors on the garage doors to reverse the door when tripped. Recommend installing these or upgrading door opener.

There are no sensors on the garage doors to reverse the door when tripped. Recommend installing these or upgrading door opener.

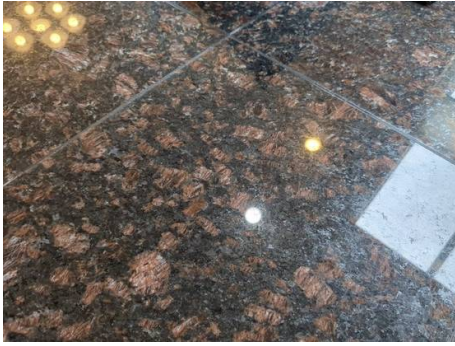
The majority of the bathroom and kitchen counters are tile and/or porous stone. It is recommended that these be sealed on a regular basis to prevent water penetration and damage.

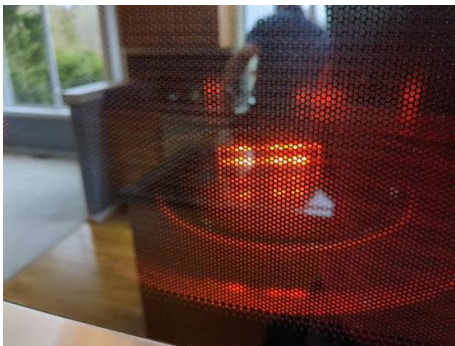
Microwave was working at time of inspection. For your information.

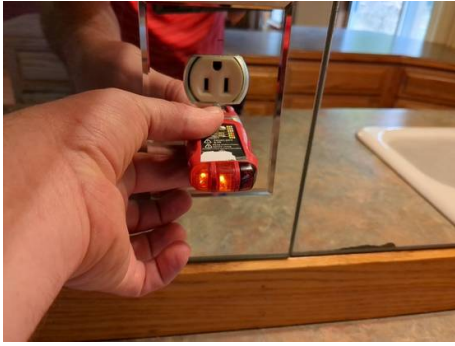
At least two of the wet bar outlets are not GFCI as needed within six feet of water. Electrical issues are considered a hazard until repaired. A qualified licensed electrical contractor should perform repairs that involve wiring.

At least two of the wet bar outlets are not GFCI as needed within six feet of water. Electrical issues are considered a hazard until repaired. A qualified licensed electrical contractor should perform repairs that involve wiring.

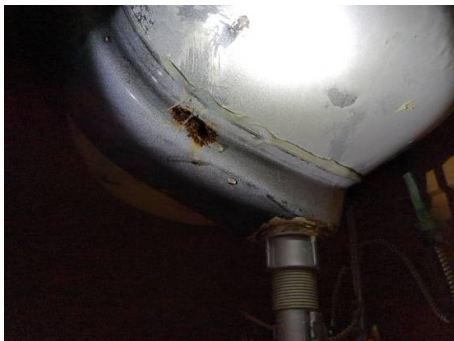
The overflow drain has signs of corrosion and rust. This indicates that the interior of the sink may be slowly rusting out. The sink on the main level is leaking at this time .Recommend monitor and replace sink prior to leakage.

The overflow drain has signs of corrosion and rust. This indicates that the interior of the sink may be slowly rusting out. The sink on the main level is leaking at this time. Recommend monitor and replace sink prior to leakage.

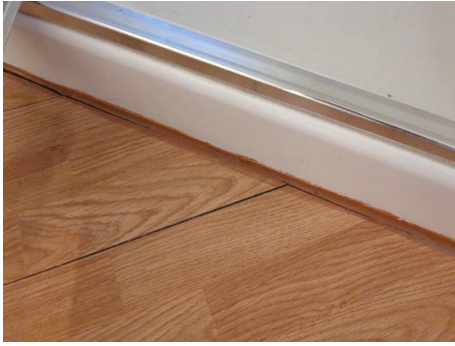
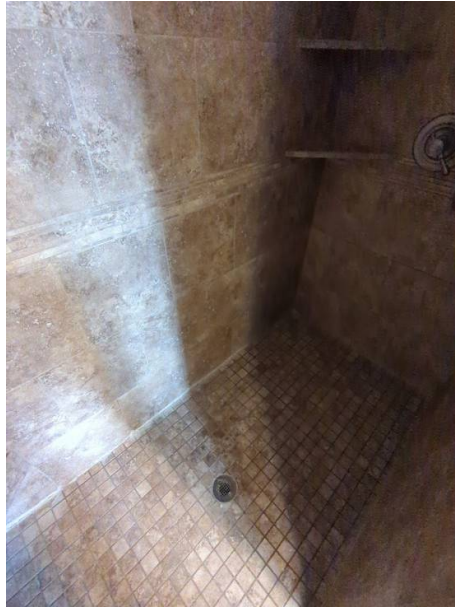
Tub/Showers

There is caulking or grout that is missing/failing along the edge of the tub surround. Recommend repairing/replacing by licensed contractor.

Grout appears not to be sealed. This is apparent by the color change when it is wet. Not all grout needs to be sealed, but it is undetermined which type of grout this is. It is recommended to ask owners which type this is, and/or seal grout to prevent premature decomposition and tile failure.

There is caulking or grout that is missing/failing along the edge of the tub surround. Recommend repairing/replacing by licensed contractor.

Grout appears not to be sealed. This is apparent by the color change when it is wet. Not all grout needs to be sealed, but it is undetermined which type of grout this is. It is recommended to ask owners which type this is, and/or seal grout to prevent premature decomposition and tile failure.

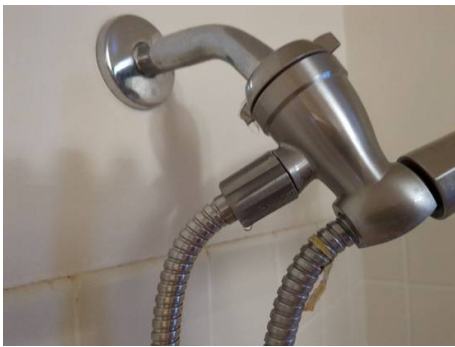
Tub/showers

The shower head leaks at connection while in use. This should be repaired/replaced by a licensed plumber.

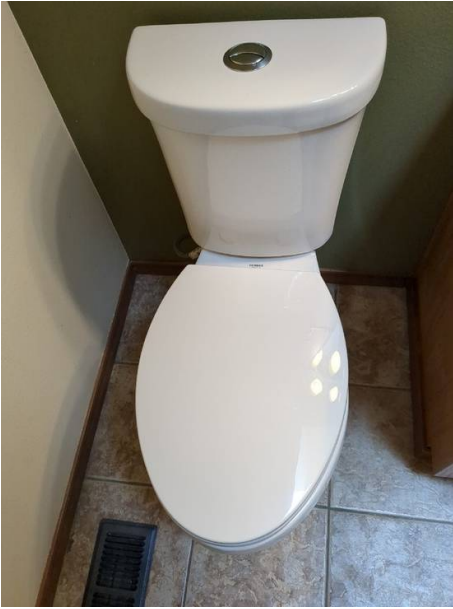
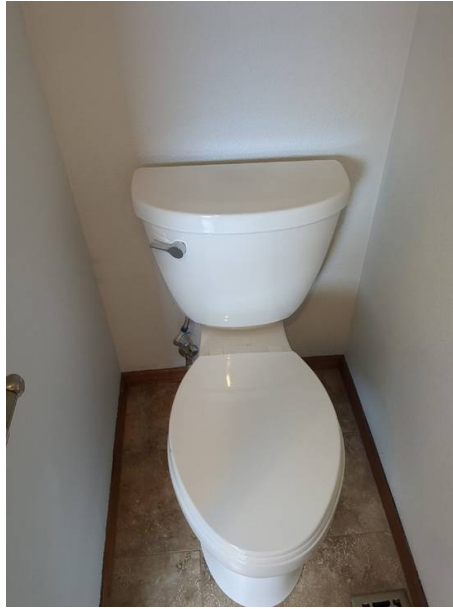
Toilets

Toilet tank in two bathrooms are slightly loose and moves. This can lead to a leak and damage. Recommend properly securing this.

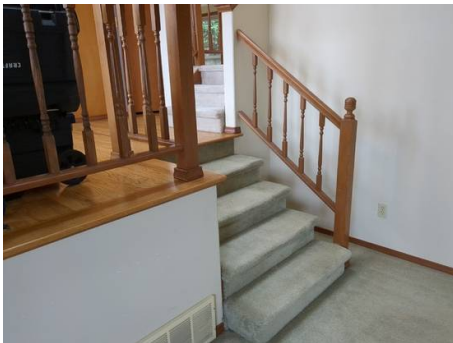
The railing on the stairs is not to today's safety standards (too large of a gap between pickets). This can potentially allow a fall or injury. Recommend updating as needed.

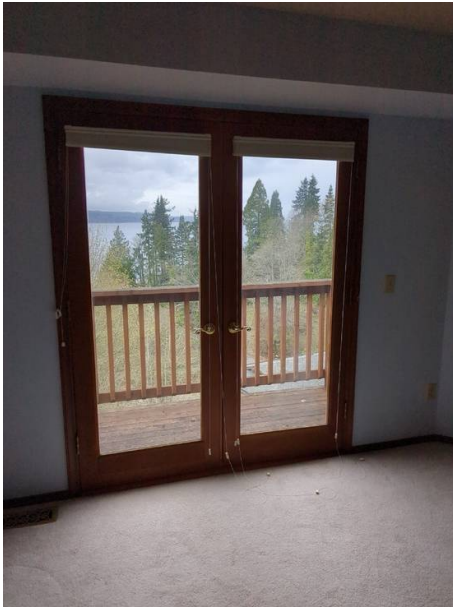
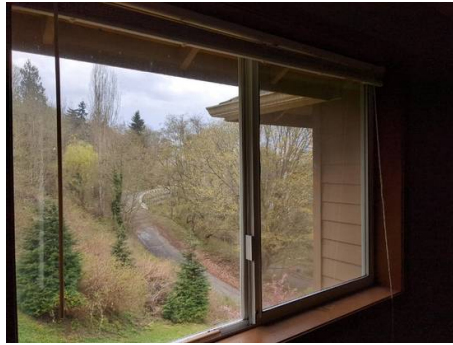
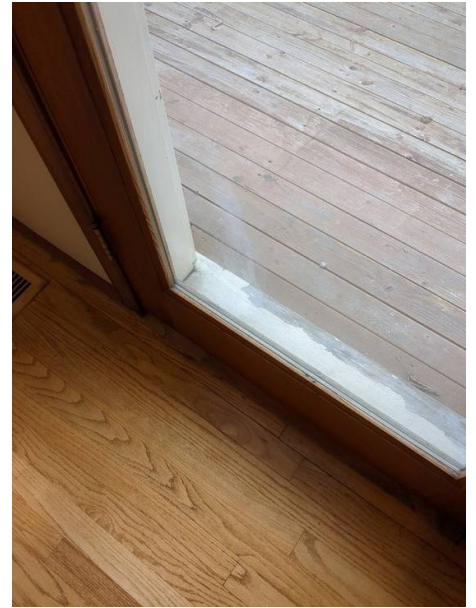
Windows are aluminum. This is a normal but dated window style. These do tend to have condensation on cool, humid days. This condensation can lead to water pooling and damage on the window sills. Recommend monitoring and/or using a dehumidifier.

There are windows that have a broken seal between the two panes of glass. This has allowed moisture in which fogs the window. It also decreases the insulation quality of the window slightly. It is recommended that the window(s) be

repaired or replaced.

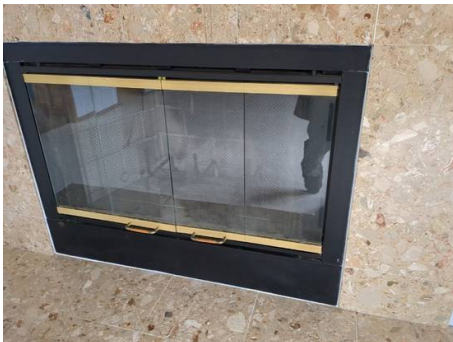
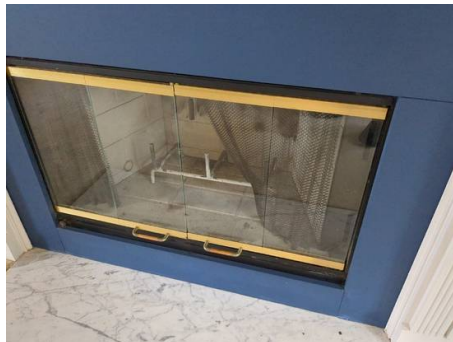
Wood burning fireplace is present. If use is desired, it is recommended to have flue cleaned and assessed by a licensed chimney sweep.

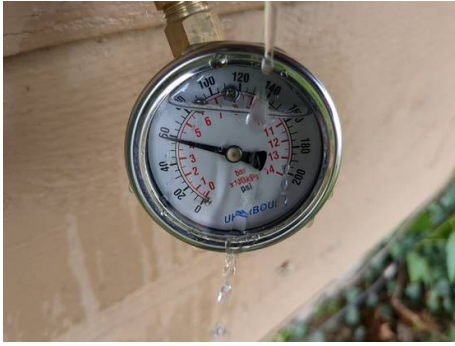
The water pressure was approximately 60 PSI. Acceptable range is 40-80 PSI with the recommend range is 60-80 PSI for your information.

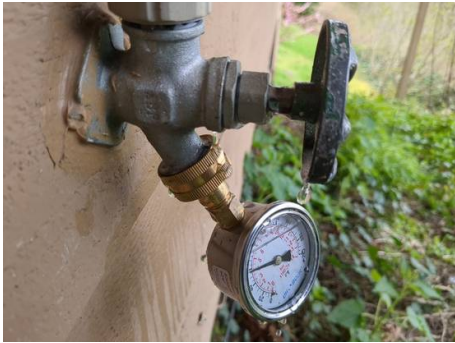
Exterior hose bib leaks while in use and under pressure. This wastes water and can potentially cause water damage. Recommend licensed plumber to repair/replace as needed.

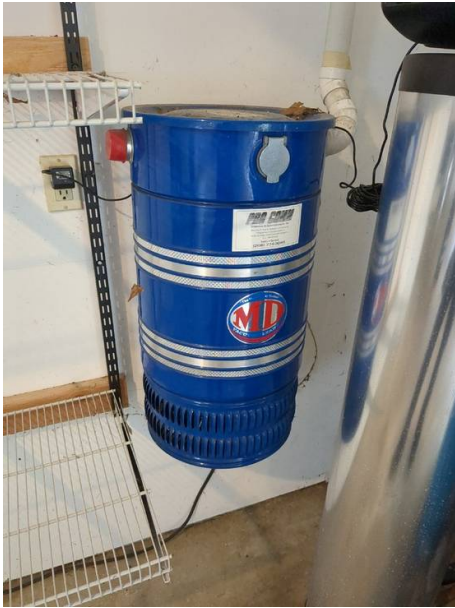
In home vacuum system is present. Disappeared to be functional but was not fully tested. For your information.

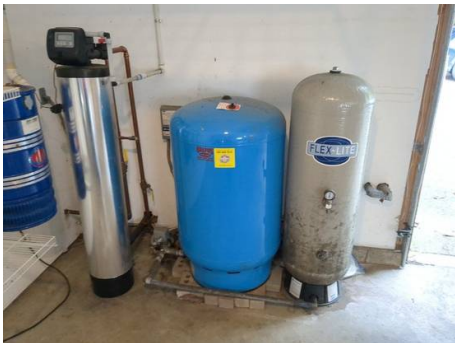
Home is reported to be on a well. Pressure tank and filtration system is present in garage. This was not fully tested at this time. Recommend this be assessed by qualified specialist. For your information.

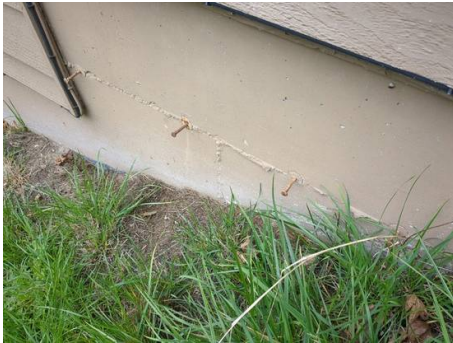
Foundation walls

Metal tie offs are still present on exterior of foundation wall. These can catch clothes or injure people. Recommend removing these to prevent issues.
